# BRIZE NORTON NEIGHBOURHOOD PLAN

APPENDIX 06
DOCUMENT G

# SURFACE AND WASTEWATER

# DOCUMENT G

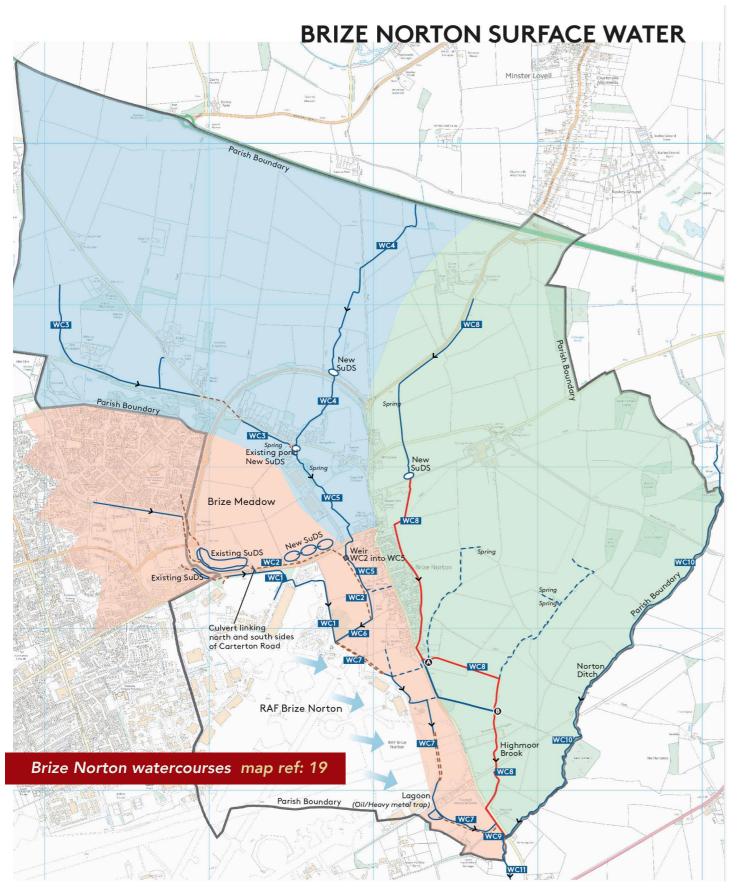
#### WATERCOURSE OVERVIEW

The village is bordered by gently falling countryside from the north west, north and north east towards the centre and south of the village. To the west of the village is the urban area of Carterton and RAF Brize Norton.

Surface water enters the village from three sub-catchment areas as indicated on map ref 19.

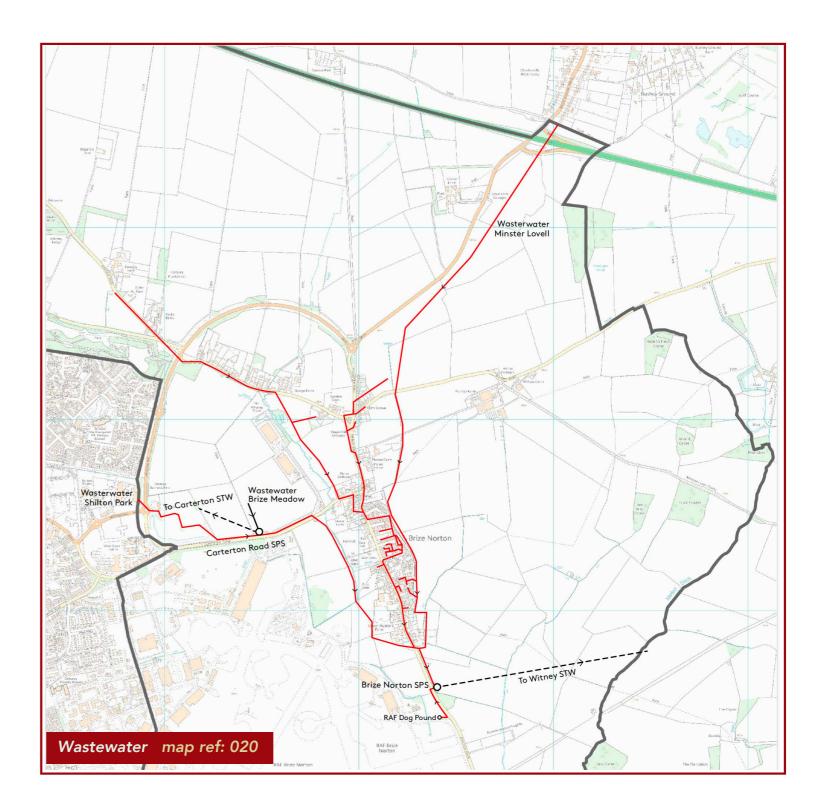
#### **WASTEWATER**

#### WASTEWATER SEWERS INTO THE PARISH

The management of Wastewater and sewers are the responsibility of Thames Water Utilities Ltd. (TW)

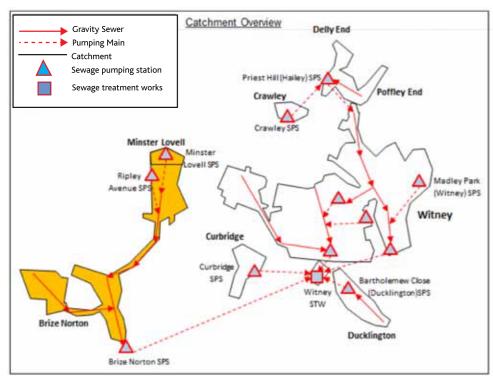
#### Witney sewerage catchment, indicating principal assets

The Brize Norton sub-catchment is highlighted orange. The red lines indicate the extent of the foul water catchment

and the blue triangles show the location of the pumping stations within the catchment.

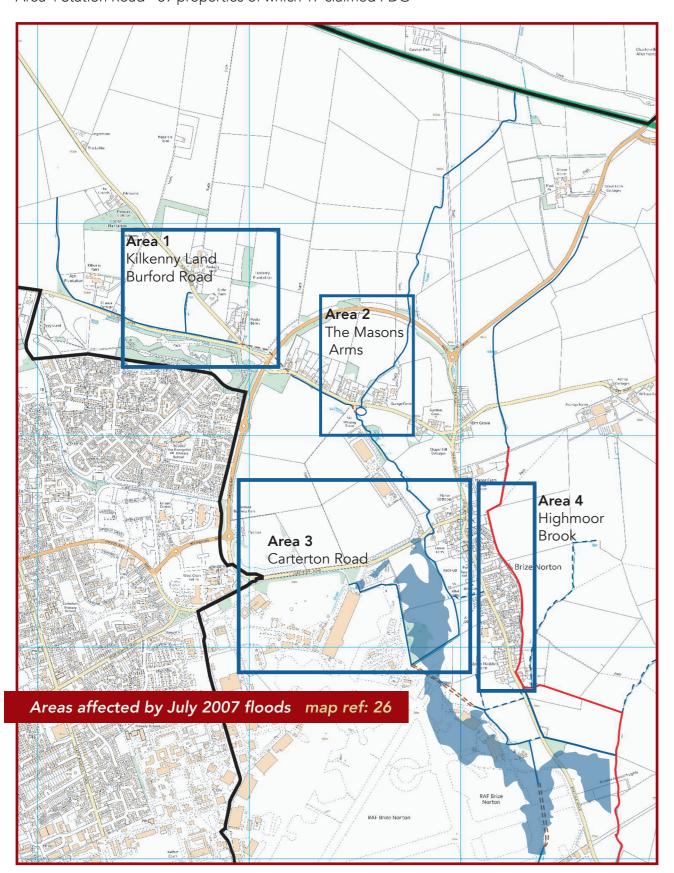
The four areas that suffered flood damage to properties were [1]: -

Area 1 Kilkenny Lane/Rocky Banks - 6 properties of which 6 claimed FDG Area 2 Masons Arms/Manor Road - 2 properties of which 2 claimed FDG Area 3 Carterton Road - 9 properties of which 7 claimed FDG Area 4 Station Road - 39 properties of which 17 claimed FDG

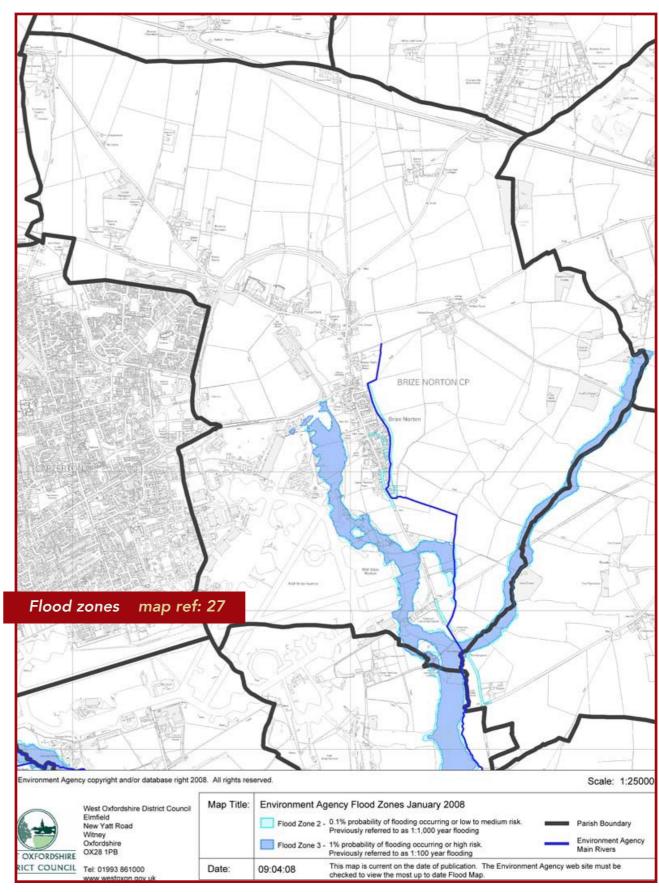
#### FLOOD ZONES IN BRIZE NORTON

As can be seen in map ref 27, some of the built-up areas in the village are either in a Zone 2, or adjacent to a Zone 3 flood zone.

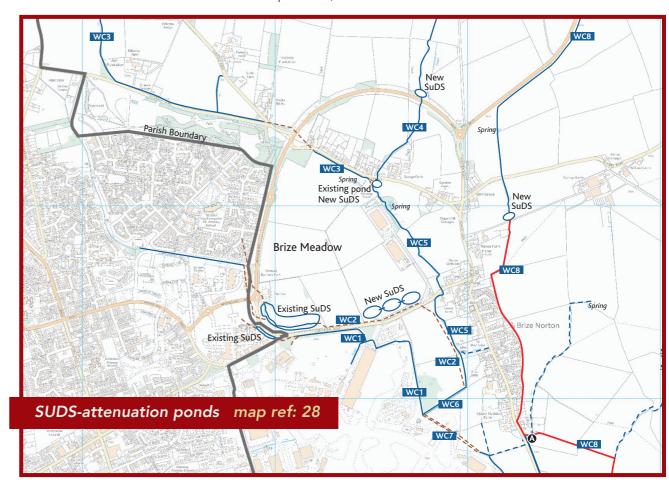
- 1) Three off-site attenuation ponds (SuDS) to be constructed as follows: -
- a. One to the north of Monahan Way to intercept WC4
- b. One to be formed opposite The Masons Arms, Burford Road to intercept WC3 and WC4
- c. One to be formed on the north side of the access road to Astrop Farm to intercept WC8.
- 2) Three on-site attenuation ponds (SuDS) to be constructed in the 'green buffer zone' at the south eastern edge of the development, north of Carterton Road. The controlled output from these three SuDS will flow into the culvert WC2 on the north side of Carterton Road.

These six SuDS are indicated on the map below;

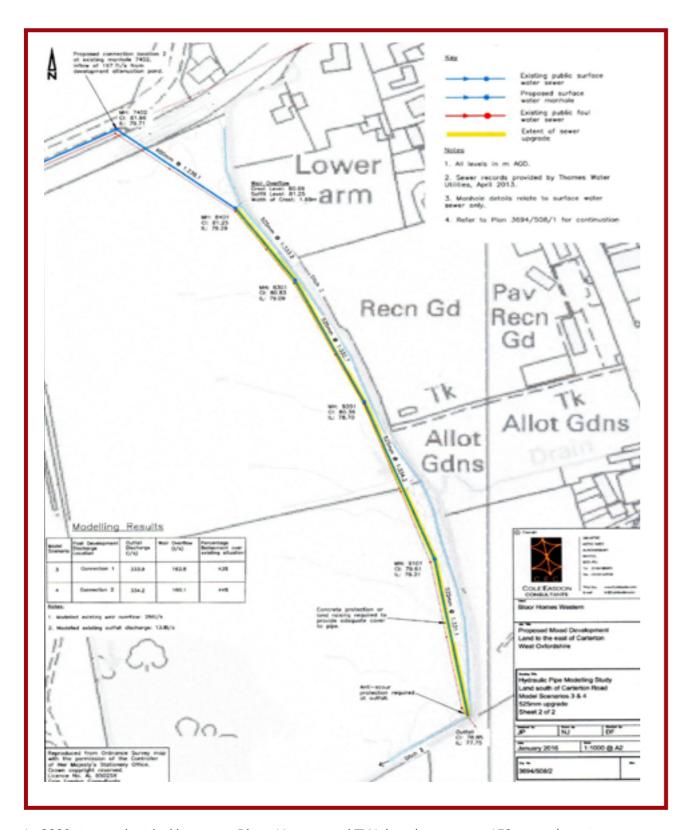
3) Upgrade the current culvert (WC2) from the north end of the field on the south side of Carterton Road to the south east corner of the field where it discharges into an open ditch (WC6), from 150mm up to 525mm diameter as detailed on the map on the next page.

In 2020, it was decided between Bloor Homes and TW that the existing 150mm culvert is to remain in its curent location and a new 525mm culvert will not be installed between the weir at the north end of the field and an outlet point into the open ditch WC 5 opposite the allotments.

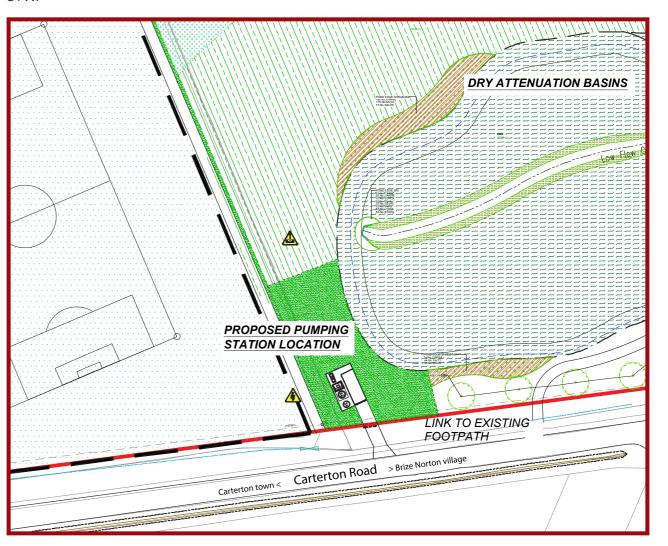
Due to the lack of capacity for the development to discharge any wastewater into the existing system feeding to the Brize Norton SPS, any wastewater will have to be directed to the Carterton STW.

To achieve this, a new pumping station will be constructed on the north side of Carterton Road, between the edge of the green buffer zone and the new football pitches. All foul water from the development will be gravity fed into this pumping station and thereafter, pumped to the Carterton STW
